Manhole Inspection Summary

Manhole # S13UU1014MH

Location Address: **NORTHERN PKWY**

Cross Street: **GREENSPRING AVE**

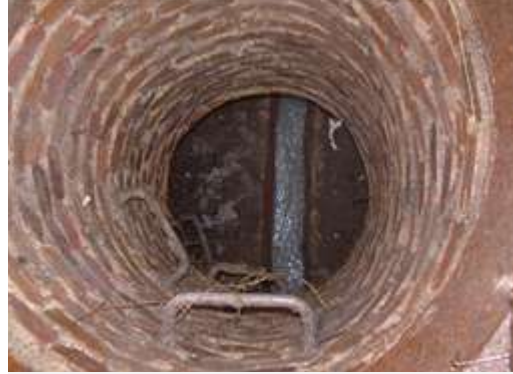
Top View

Corroded steps. Evidence of surcharge - Bench debris.

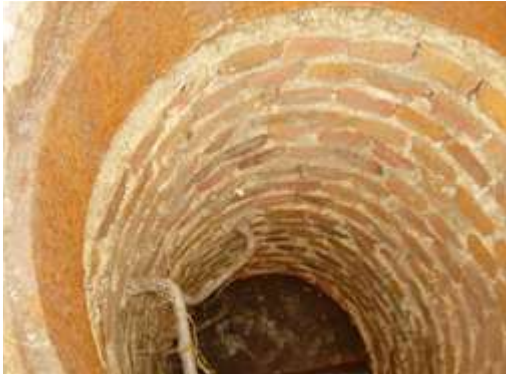
Defect

Adjustment deterioration, root intrusion and infiltration. Corbel and Barrel root intrusion and infiltration.

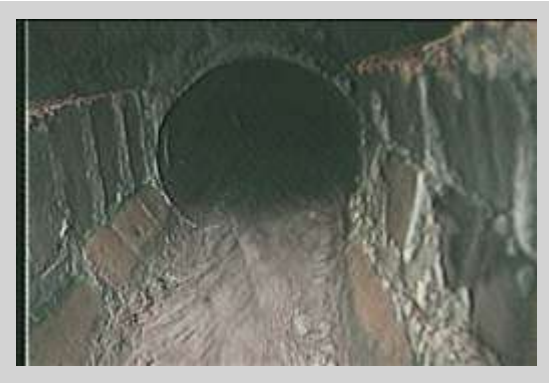
8 in. Circular Gravity Sewer Pipe Out @ 12 O'Clock

Barrel deterioration and infiltration.

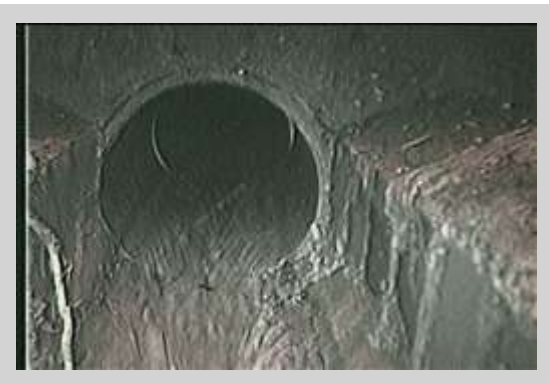
8 in. Circular Gravity Sewer Pipe In @ 6 O'Clock

Channel deterioration.
